## MAKING ROOM FOR SWIFTS

#### An Architect's Case Studies

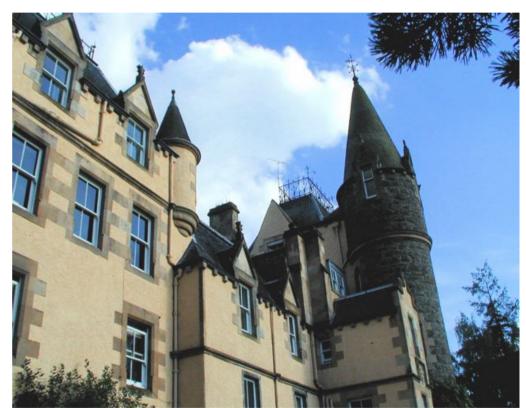
The roof was replaced over a series of phases in the past 15 years. There was a large lead flat between the two wings which involved the replacement of the entire roof over an area of about 70m2 and rebuilding it with a new ventilated lead roof. The edge of this roof can be seen just behind and above the two lower stone gables in the main photograph.

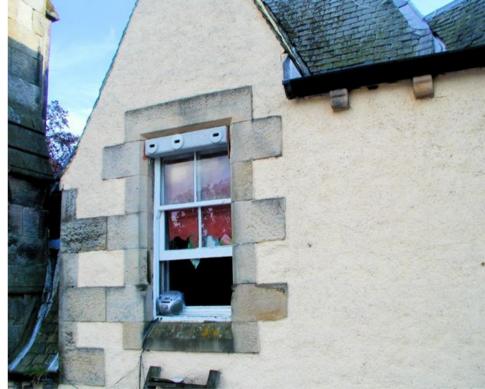
- We knew there is a busy population of swifts in Auchterarder which is plainly visible from the Cloan frontage.
- We knew that the Schwegler triple box was almost exactly the same width as the attic window adjacent to where the swifts had nested previously (910mm), so our strategy was to firmly fix the nest box high up in the window reveal, without damaging the stone jambs, to coat the glass of the window with dust to prevent bright reflections and to play the CD through the east facing window below and also at a high window facing south to Auchterarder. The CDs were left to run almost constantly.

- Swifts were once again seen at Cloan, wheeling around the west wing roof and clearly responding to the calls they were heariing. It appeared that on more than one occasion they were inspecting the building, up close. This was borne out when a swift was found to have flown into the gap left in the window for the CD broadcast. The visitor was liberated before it came to any harm.
- The call CD at one window was played all summer and the swifts were regularly seen flying around so we hope the extended period of visits has imprinted Cloan for next year. The nests will be blocked up over the winter and re-opened nest spring. Even if there are no takers next May we will continue to try to establish Cloan as a nest site. When we have done this more permanent nest sites will be provided.

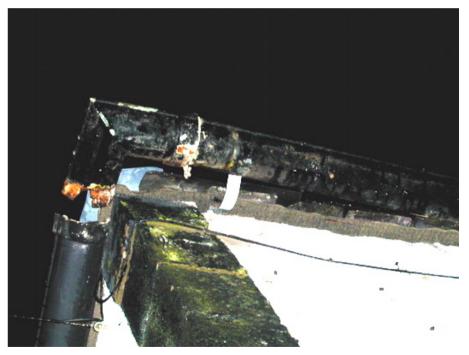
- The roof at Glenhead was replaced six years ago, programmed to begin mid-August. Strict instructions were given on how to maintain the nest sites.
- The instructions were not followed and the following year six or seven pairs of swifts were unable to gain access. It was observed that they tried to gain access with some determination but they eventually gave up and left.
- This picture shows one nest site between the quoin and the rone bracket and the offending felt

- The rones were taken down in the autumn, cutting out the blocked up openings where we could. The introduction of ordinary roofing felt created problems - it lay loose under the slates at the nesting gap so metal plates were made and thin slate acquired which were tapped into the wall head to raise the felt up from the opening. These "shims" rode on the same high points on the harling but were thin enough not to give the edge a noticeable "kick". The nest holes along the south and east wall heads were scraped out and left for the next May. Unfortunately no birds returned.
