Angus Council and Tayside Biodiversity Partnership

**ANGUS COUNCIL SuDS AUDIT AND  
BIODIVERSITY VALUE REVIEW**

Sarah CLEMENT - April 2017

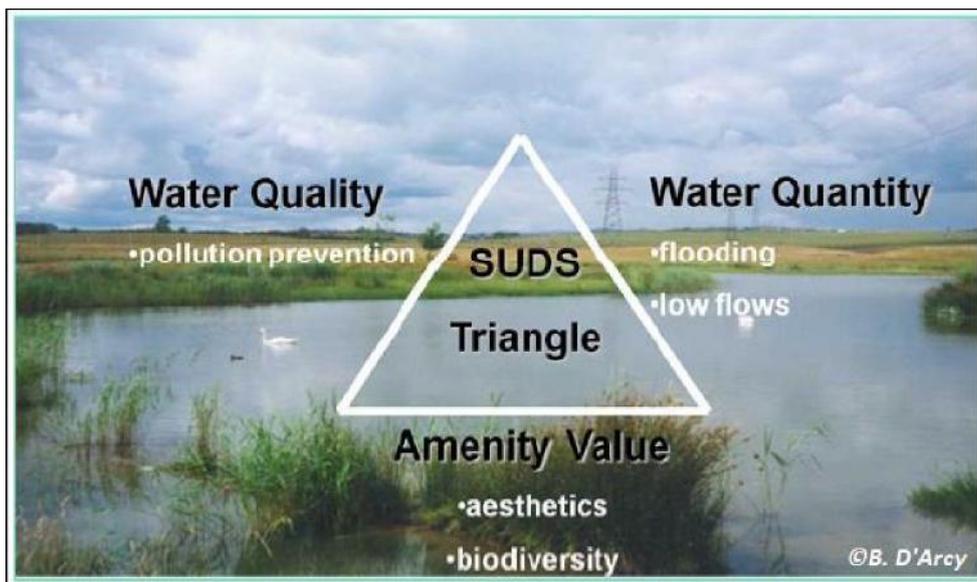
**Figure 1:** The Sustainable drainage triangle concept for multiple benefits of SuDS (D'Arcy 2013)<sup>8</sup>

A very useful study would be to undertake a survey on awareness of SuDS function for the inhabitants of Angus, asking about the three aspects of SuDS (*Figure 1*).

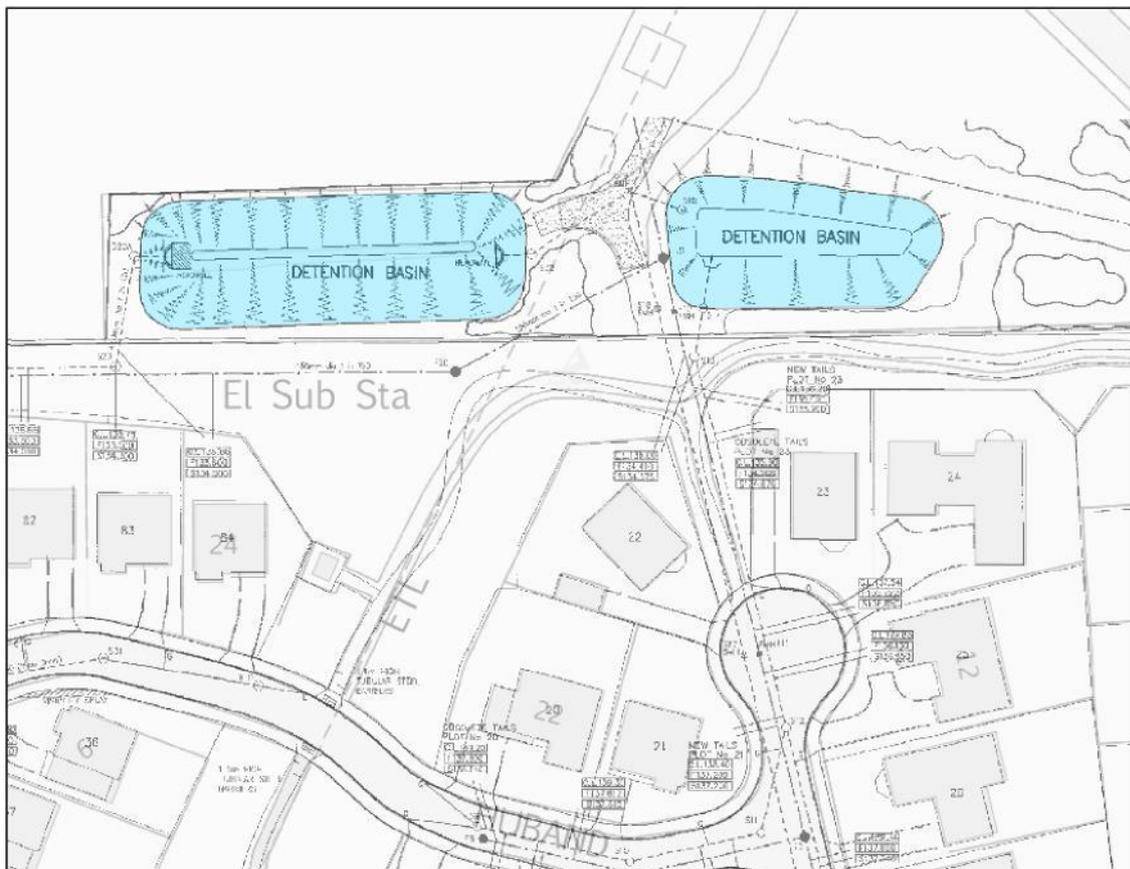
The first part of the work is to identify all the SuDS in Angus. An email asking for information was sent to the Council's planning team of Angus Council. Then, every plan of new developments from 1992 were studied to find all the SuDS. These plans were on the Angus Council computer system. All information received was checked against an OS map and an aerial view from the Council's GIS systems on the software Qgis. Some SuDS could not be found because of the age of the layers. Once all the SuDS identified, they were mapped on Qgis as polygons. The PDF plans have been put on Qgis and geo-referenced. The polygons have been created, following the trails of the plan (*Figure 2*).

**Figure 2:** Example of a plan geo-referenced and the drawing of the contours

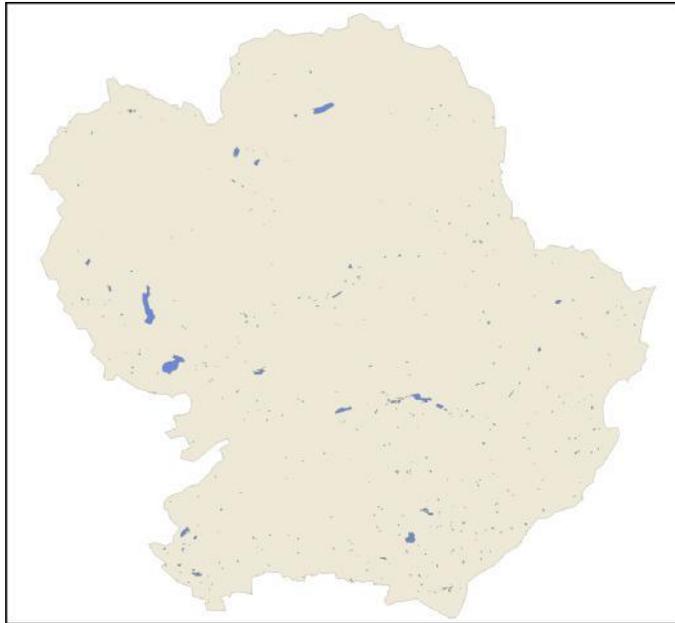
A total of 573 ponds and loch have been mapped, distributed around the territory (*Figure 6*). The smallest one was 5 m<sup>2</sup> and the largest one was 1, 793, 724 m<sup>2</sup>.

*Figure 6: Map of Angus with all the ponds and lochs*

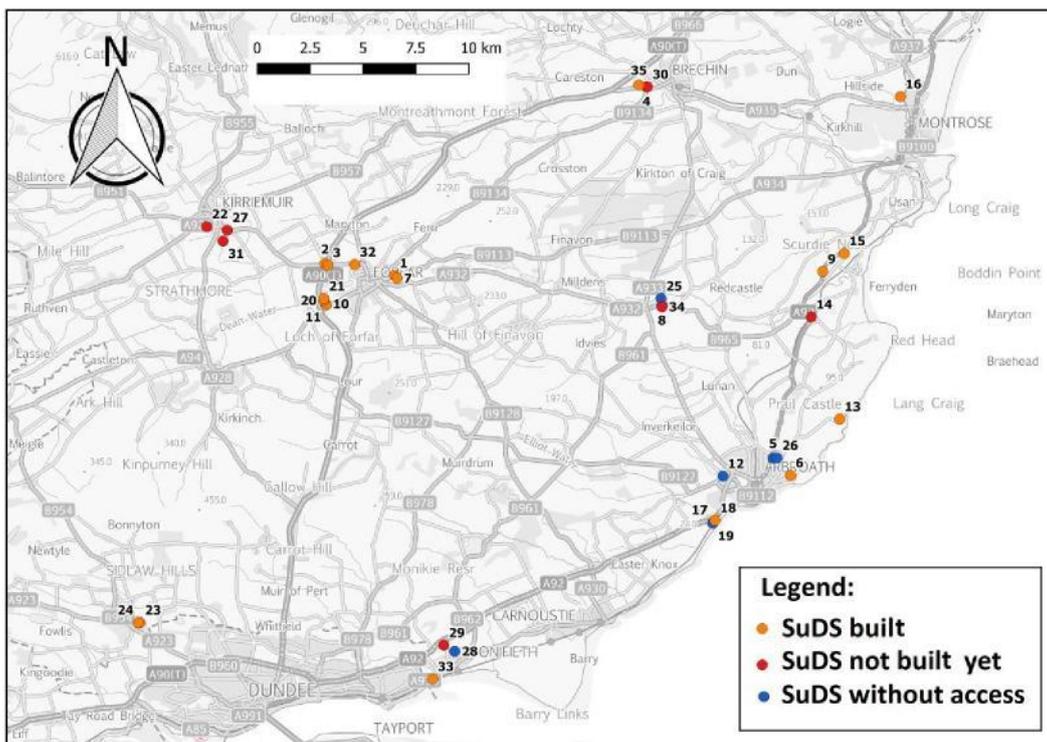
35 SuDS have been found in Angus with only detention basins, no retention basins. 20 of the detention basins were already built, 8 were not built yet and 7 cannot be accessed (*Figure 7*).

*Figure 7: Location of SuDS in Angus, with their ID and their status*

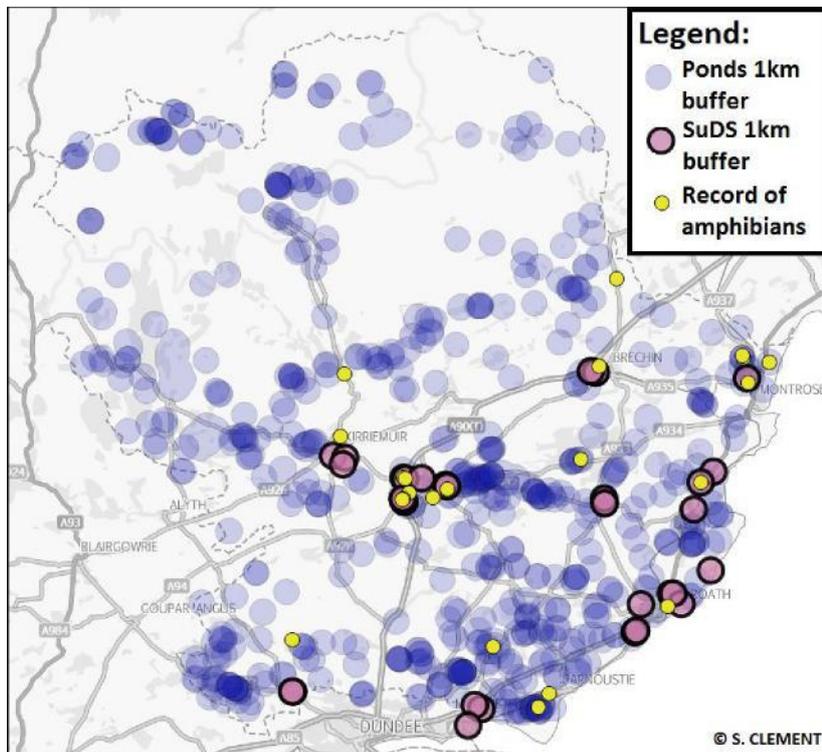
With all the information put in the software Qgis, we've been able to create several maps. One of the most interesting is the one with the buffer of 1 kilometre around the ponds and the SuDS and with the report of amphibians by the public (*Figure 31*).

**Figure 31:** Map of Angus with the report of amphibian, the 1km buffer around the SuDS and the ponds

This map is very interesting because it shows potential blue corridors and the beginning of several migration routes. SuDS can be very important in these migration routes and have the potential to contribute towards the safeguarding of local amphibian populations. For example, the three SuDS in

Kirriemuir could help the amphibians to cross the town in the axis North-West/South-East. In Arbroath, they can provide a very good place for them to breed. Globally, the SuDS are covering the biggest part of the towns, permitting the amphibians to migrate. The ponds and lochs are quite well distributed on Angus. The north is more fragmented but there are a lot of wetlands in this area which compensate this lack of ponds and lochs.

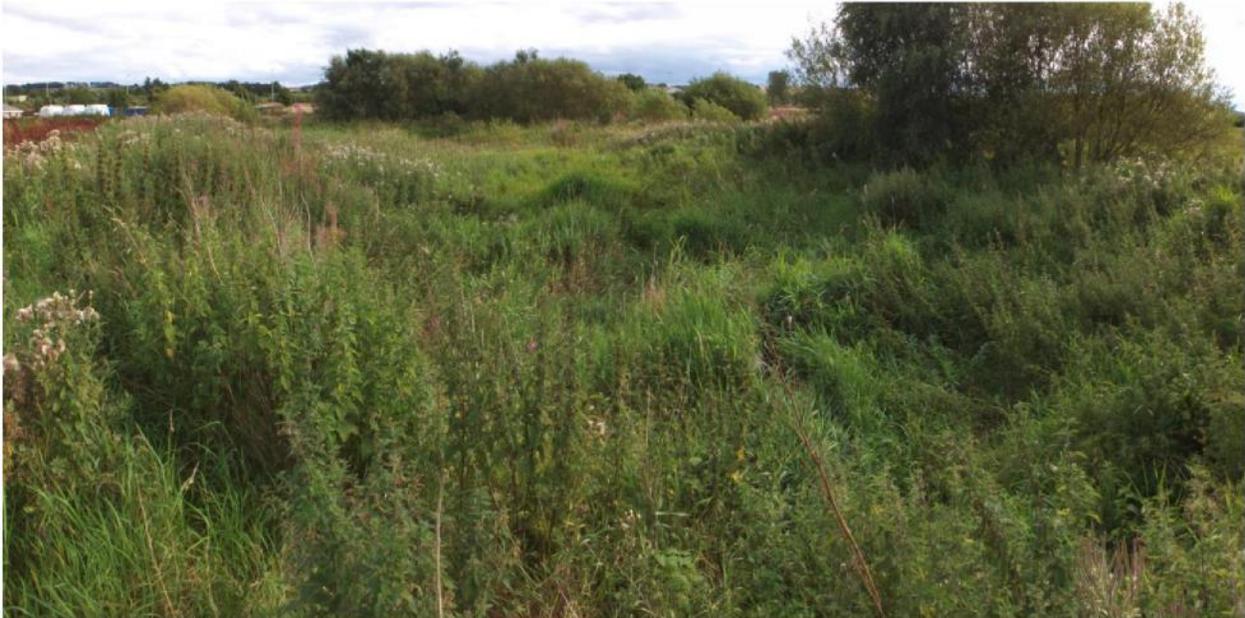
This is a dry SUDS basin surrounded by rough grassland and scrub. Though the site is unfenced, access is easiest through the grassland from the north or east rather than from the footpath to the west.

Litter: none

Water depth: N/A

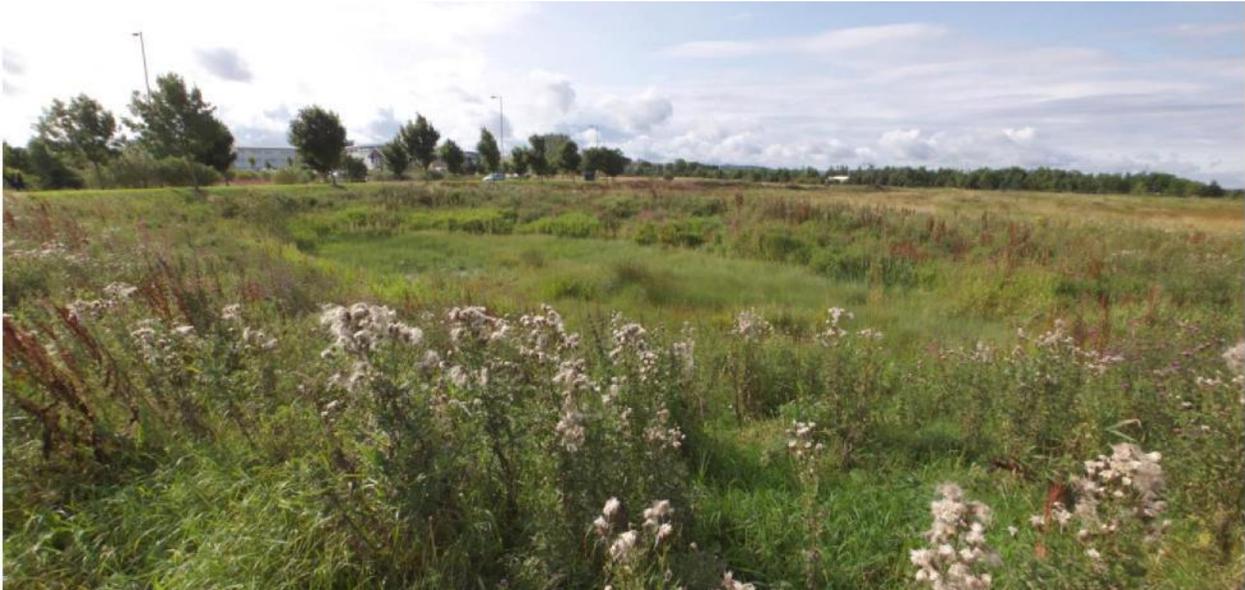
This is shallow pond with gently sloping banks, surrounded by tall ruderals on all sides. Footpaths lie to the south and east, with rough grassland areas to the west and north. The nearest road is 15m away, to the south of the pond. The water was clear, though filled with algae.

Litter: none

Water depth: 16cm

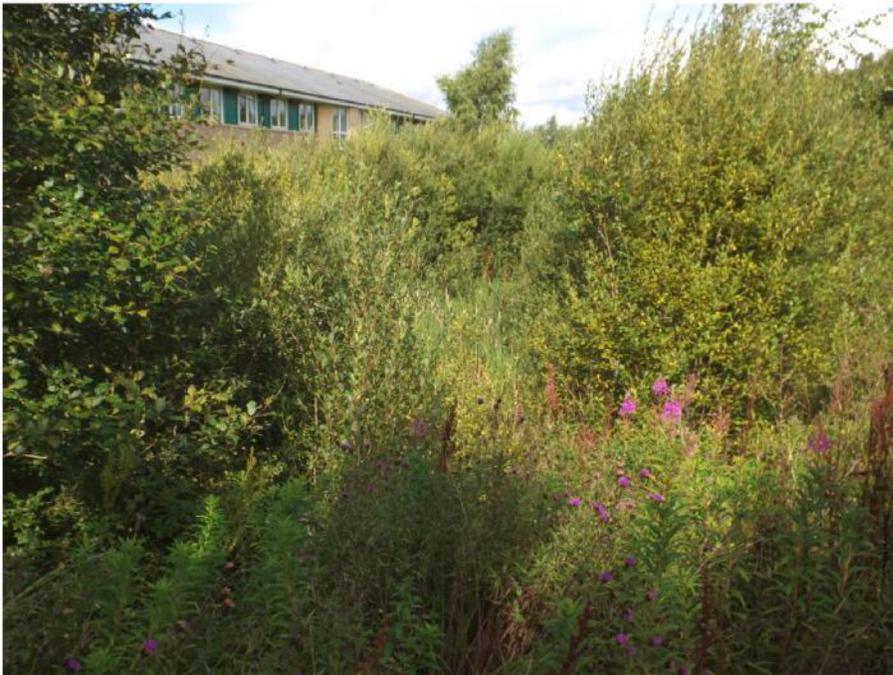
This site is a small pond, obscured from view by numerous surrounding shrubs and not readily accessible. To the west there is a car park, and to the south and east a footpath, a small burn also flows past on the east.

Litter: none visible

Water depth: N/A

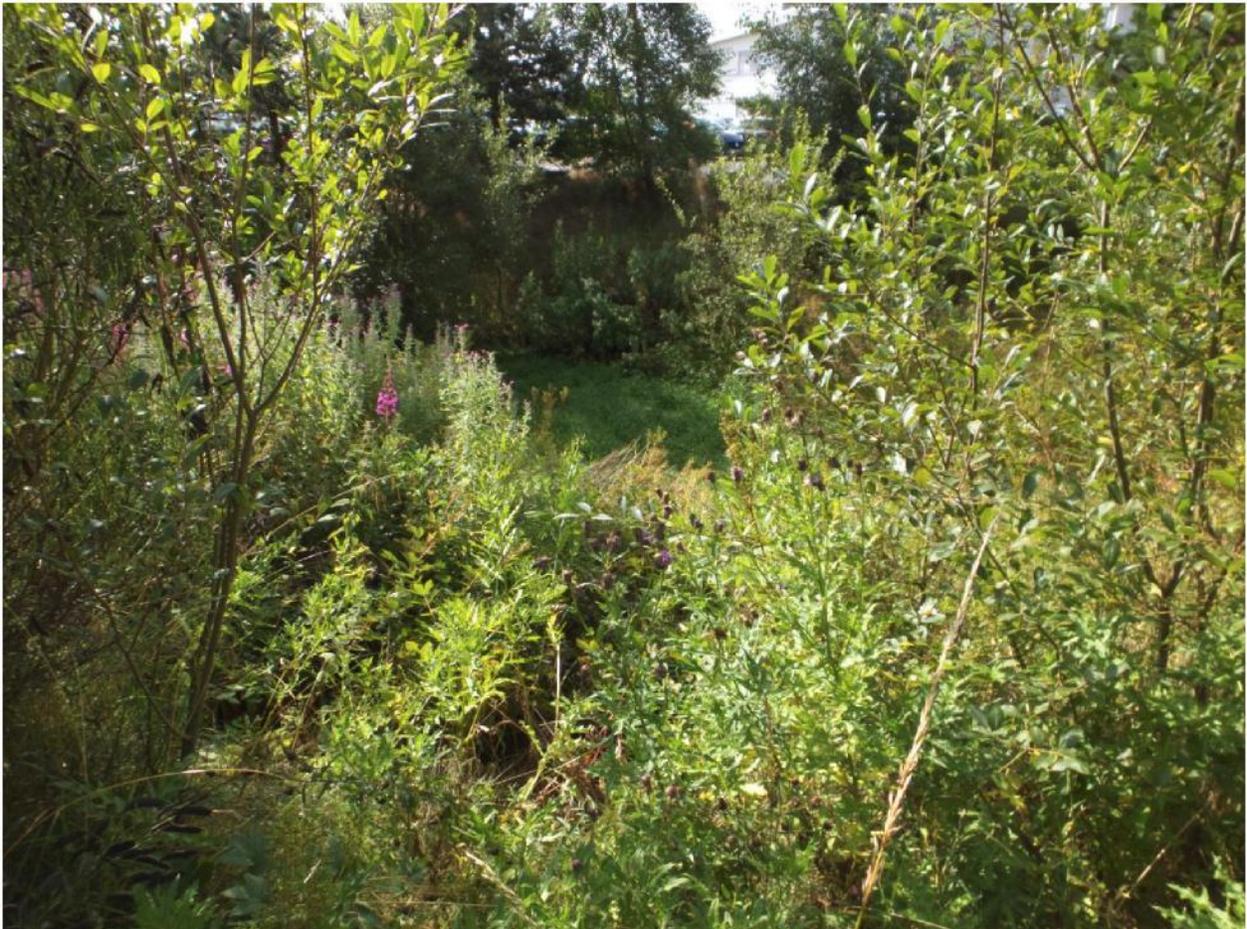
This site is a small pond, obscured from view by numerous surrounding shrubs and not readily accessible. To the west there is a car park, and to the north and east a footpath, a small burn also flows past on the east

Litter: small amount

Water depth: N/A

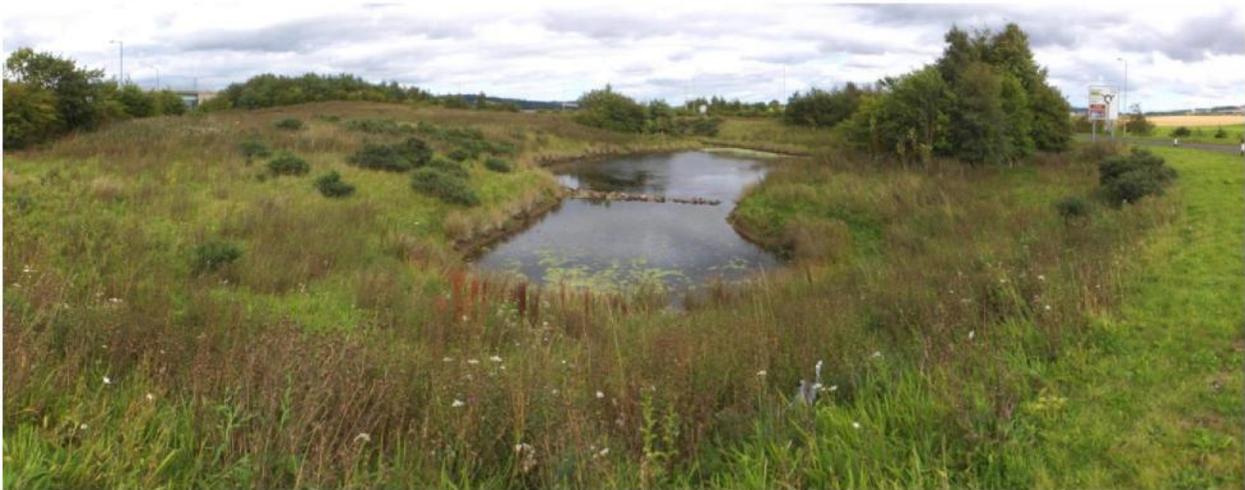
This SUDS is a large area of open water surrounded by rough grassland. The site lies just off the main road and has no footpath meaning that, although it is unfenced, it is not readily accessible. The banks are quite steep in areas, with the basin quickly becoming deep.

Litter: some large items (plastic, car parts)

Water depth: 50cm

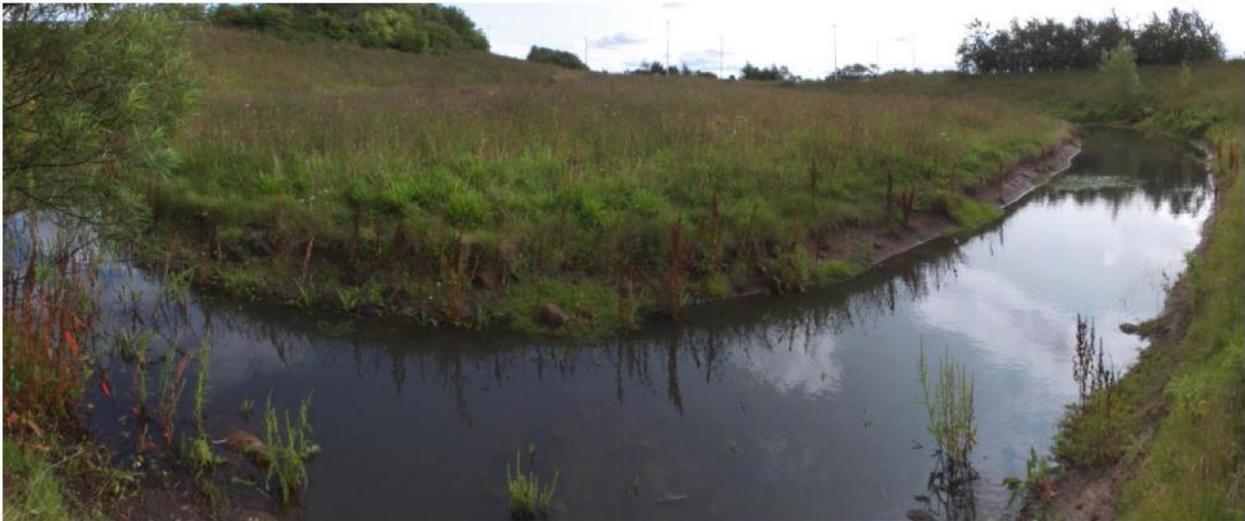
This is an unfenced site beside a busy road, with access only by crossing the road onto the grassland area. The site is almost entirely encircled by the road, but is still at a distance of over 10m away on all sides. The grassland consists of wildflowers and grasses, with some encroaching shrubs. On the northern slope is a treeline, around 10m tall. The wet area is a 2m wide crescent shaped channel

Litter: none

Water depth: 20cm

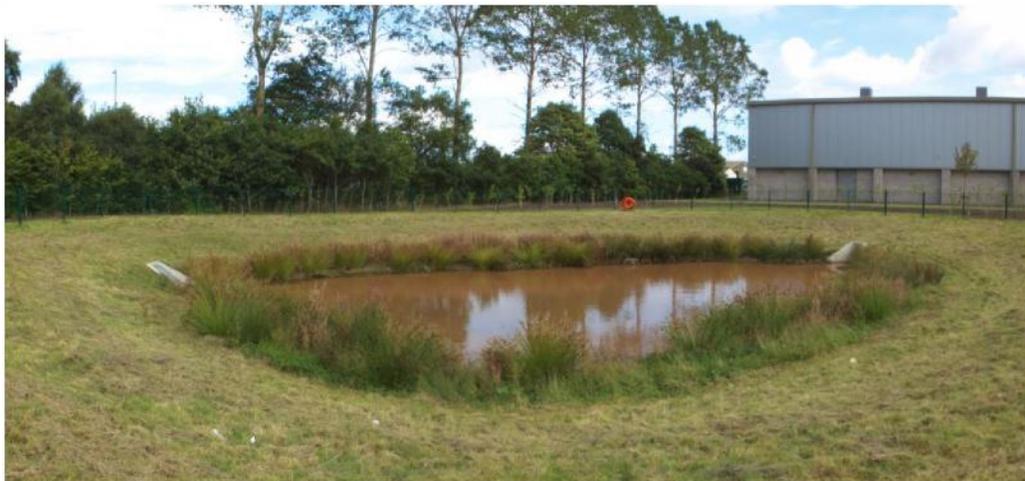
The pond is situated within a newly created green space, surrounded by groups of young trees in tubes and a circular path. It was fenced off and only readily accessible with keys. The nearest road is around 20m away, obscured by a taller row of trees and shrubs. The community campus lies to the East, there are astroturf sports pitches to the west, and ongoing construction works to the south.

Litter: small amount

Water depth: N/A

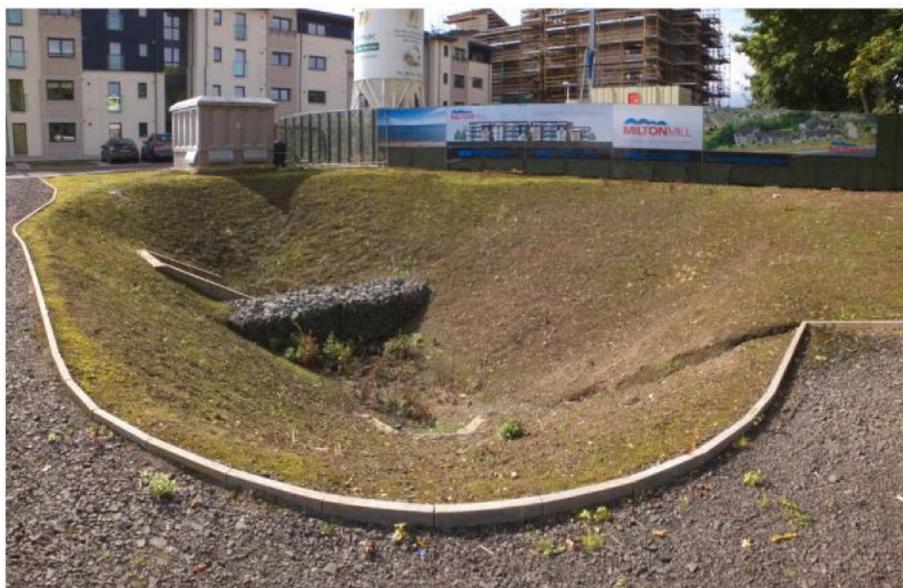
The SUDS is a small, dry basin, patchily vegetated by pioneer species and some ruderals. There is no restriction to access, and the basin lies next to a footpath. To the South there are flats, and there is ongoing construction to the east. The Dighty Burn runs past to the north roughly 30m away.

Litter: small amount

Water depth: N/A

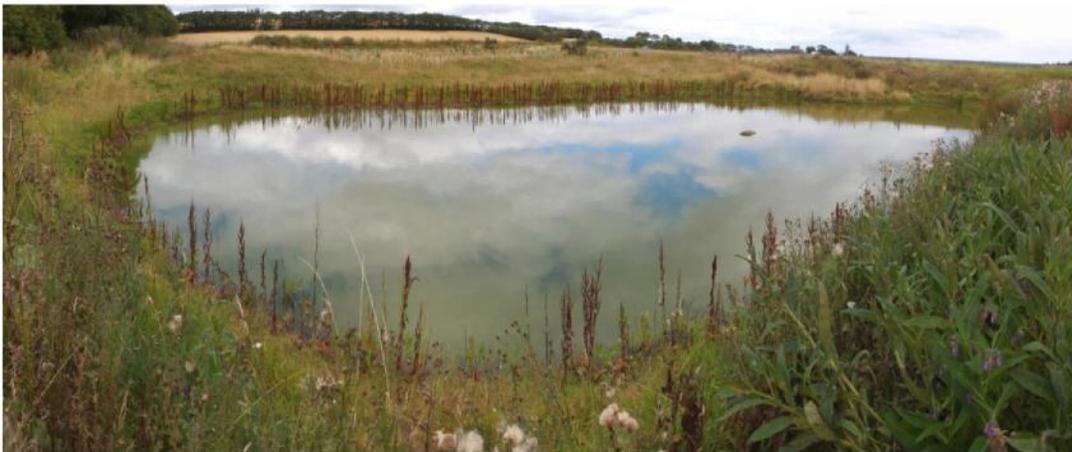
The SUDS consists of a dry ditch and a large basin surrounded by grassland, scrub and an area of planted trees. The area is fenced but currently accessible by an unlocked gate off the main road, which passes around 10m from the basin. The basin is steep sided and the standing water within the basin is opaque and green in colour.

Litter: none

Water depth: 45cm

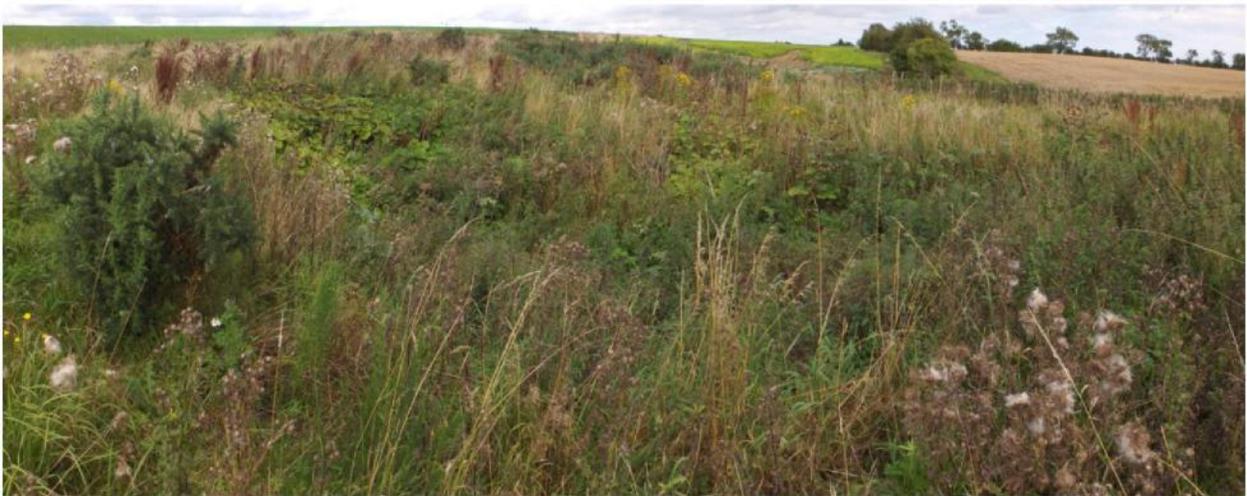
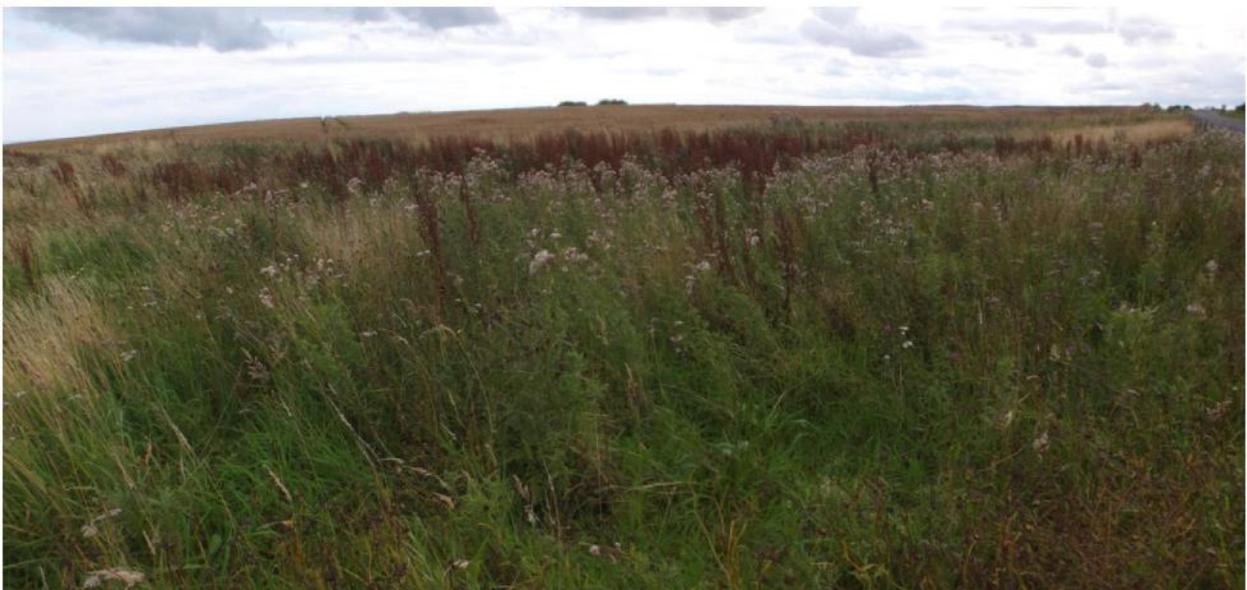
The SUDS consists of a dry ditch and a small area of slow running water and is surrounded by dense vegetation. The habitat is predominantly unmanaged rough grassland, with arable fields around the perimeter. The road is around 20m away to the north west, access to the site is restricted by a locked gate.

Litter: none

Water depth: N/A

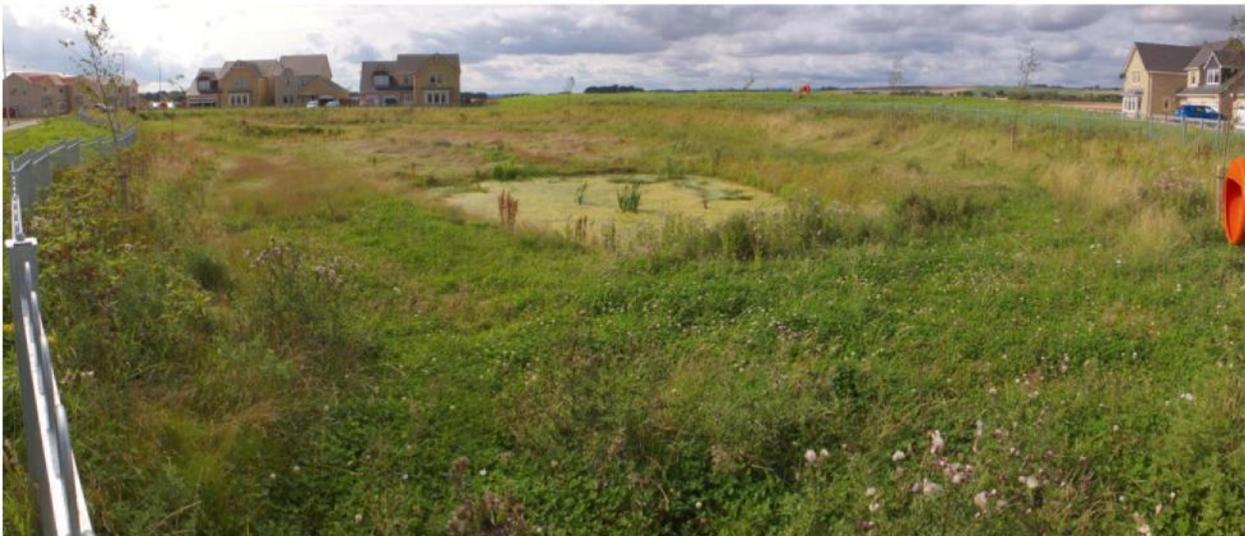
The SUDS consists of two ponds linked by a channel, within an area of semi-improved grassland. There is an area of wildflowers around the outer perimeter of the fence line, and occasional small trees. Surrounding the site are houses, and a road around 15m from the ponds. Access to the site is restricted by locked gates.

Litter: a large volume of plastics

Water depth: 11cm

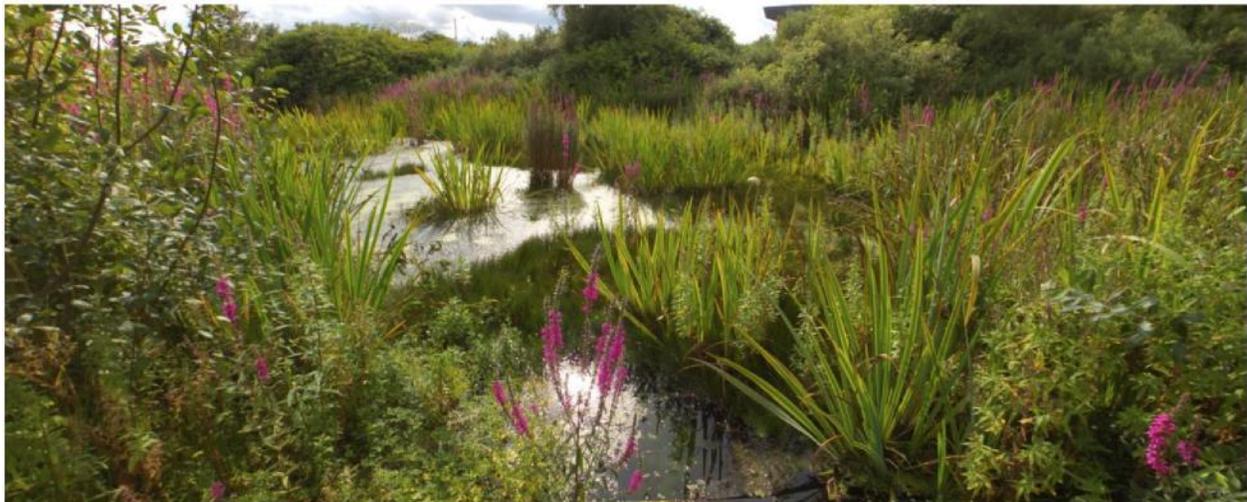
The site is situated between two industrial buildings, and set away from the main road but with car parks immediately east and west. The pond is unfenced, but access is restricted around most of the perimeter by dense vegetation. The pond basin is wide and relatively shallow with gently sloping banks. There is a thick layer of silt, over 5 inches deep in some areas.

Litter: small amount

Water depth: 10cm
