Amphibians in Drains Project 2010 Perth & Kinross Ranger Service

Perth and Kinross Countryside Ranger Service
Perth & Kinross Council
Pullar House
Kinnoull St
Perth
PH1 5GD

Introduction.

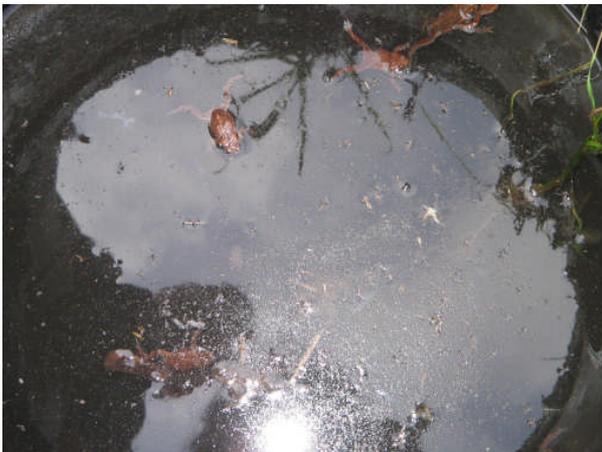
Toads trapped in gullypot, Kinclaven Rd, Murthly.

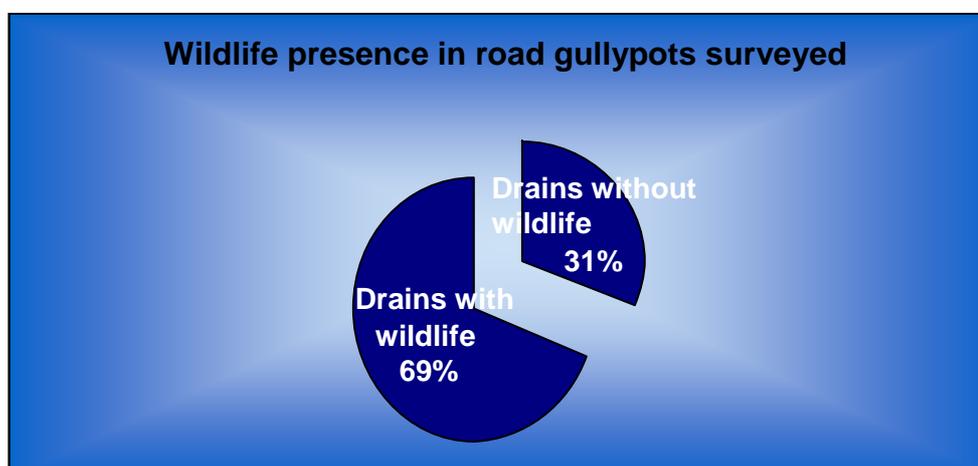
Graph 1 – Wildlife presence in gullypots surveyed

With almost seventy per cent of the gullypots surveyed by the Ranger Service containing amphibians, it can be seen that a significant number of drains are acting as traps to wildlife crossing roads or moving along the side of roads (see Table 1 and Graph 1). In urban areas there is the added hazard of high kerbs which can act as a further channel into roadside gullypots. A huge amount of wildlife across the country must be affected by the presence of gullypots.

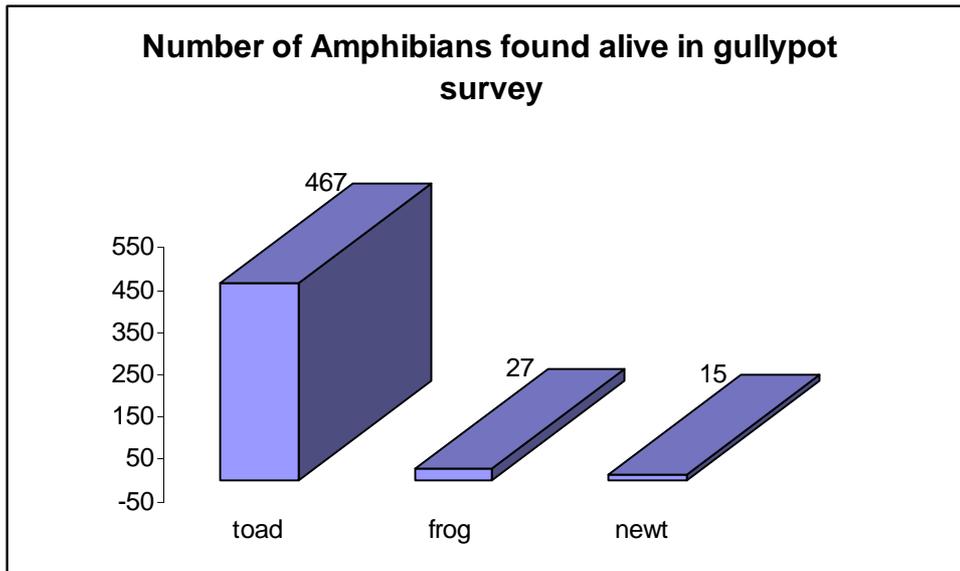
Graph 2 – Wildlife found alive in gullypots, breakdown by species

Toads are by far the commonest species found in gullypots, reflecting the toads' commoner status in the area. Toads made up 509 individuals/ 92% of the number of live animals found, and 96% of dead (126). Frogs made up 5% of the number of live animals found (27) and 2% of dead (3), while newts made up 3% of the live animals found (15) and 2% of dead, with three individuals (see graphs 2 & 3).

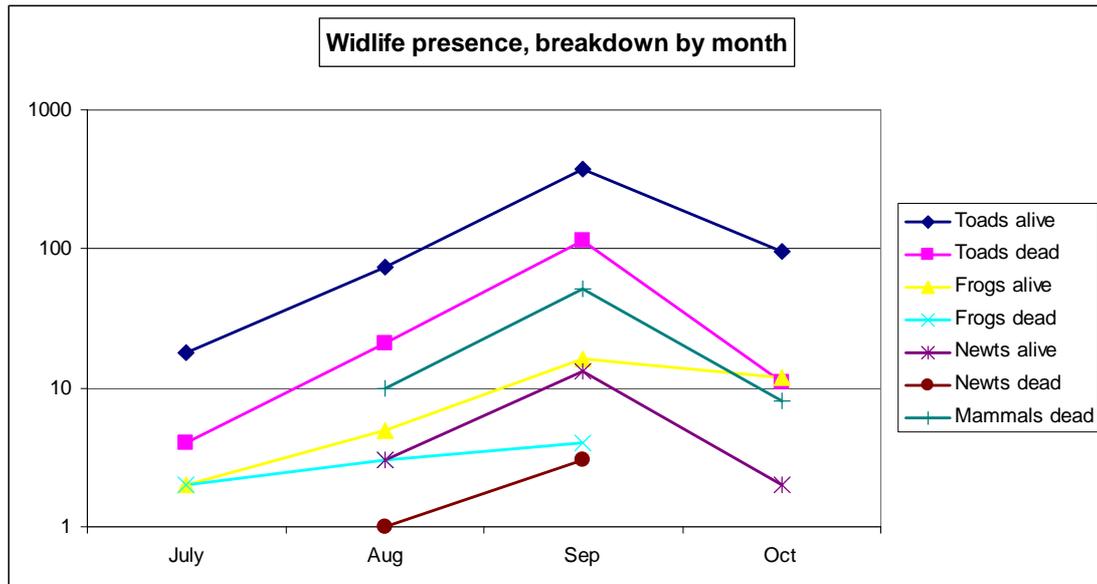
Graph 4 – Wildlife found in gullypots, breakdown by month

From graph four we can see that the greatest number of animals were found in September, which is the time of year when amphibians will be dispersing to their hibernation grounds. It will be useful to see from data collected in 2011 and 2012 what the numbers will be in early spring when populations make their way to breeding ponds.

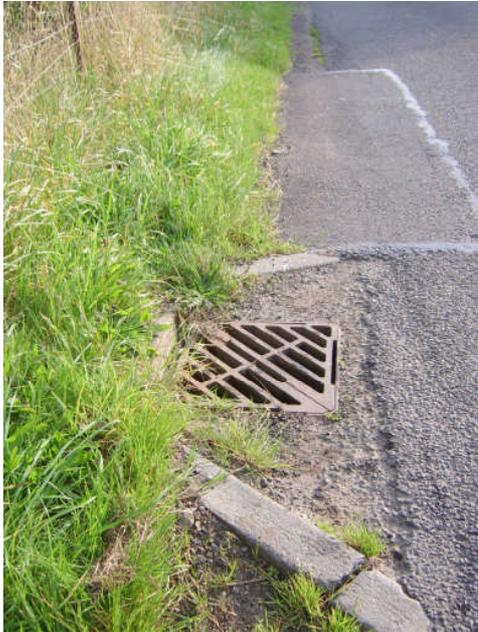
Gullypot drain cover.

It was initially thought that it would be worthwhile collecting information on gullypot design and seeing if there was any correlation with the number of animals trapped, however only 4% of drains surveyed were not standard plastic design so this will not be recorded in future surveys. Gullypot design can be seen in diagram 1 in the appendix.

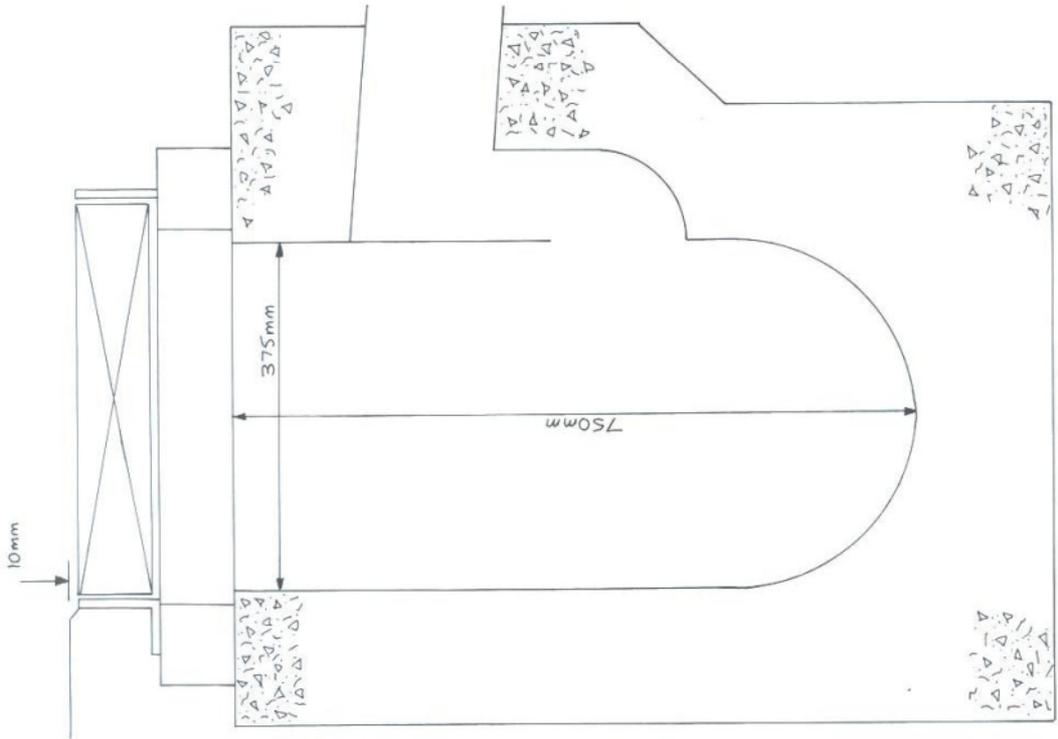
Diagram 1 – Design of plastic gullypot and Table 2 - Recording card.

1. Gully grating and frame shall be in accordance with B.S EN124 D400 1994.
2. Gully grating to be set 10mm below carriageway profile on a full mortar bed of 1:3 cement/sand bed.
3. Gully grating and frame to be laid on a precast concrete slab.
4. Gully pot shall be surrounded with 150mm thick concrete, class 22.5/20.

This is the first year of a three year survey and more data will be collected in 2011 and 2012. However, initial findings would suggest gullypots could have a significant impact on local populations of amphibians. Some kind of ladder or ramp which would allow amphibians and mammals to escape from the drain would be beneficial. The design would have to be such that it would not interfere with the drainage efficiency of the gullypot.
