Roof Repairs & Re-Roofing with Swifts

Follow these simple guidelines to comply with the law and keep Swifts safe and breeding in your roof.

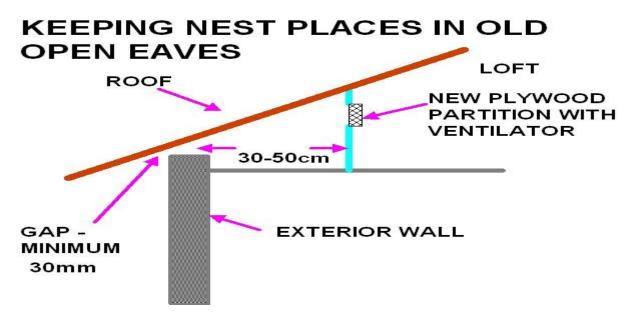
If you have to, install a ventilated plywood partition at least 30cm inside the loft to enclose the Swift nest areas and make the loft area usable, as shown below. *More drawings and details are shown on the last page.*

Eaves nests- leaving the eaves open is the simplest & best solution or cut slots in the soffit or facing boards to match the old entrances

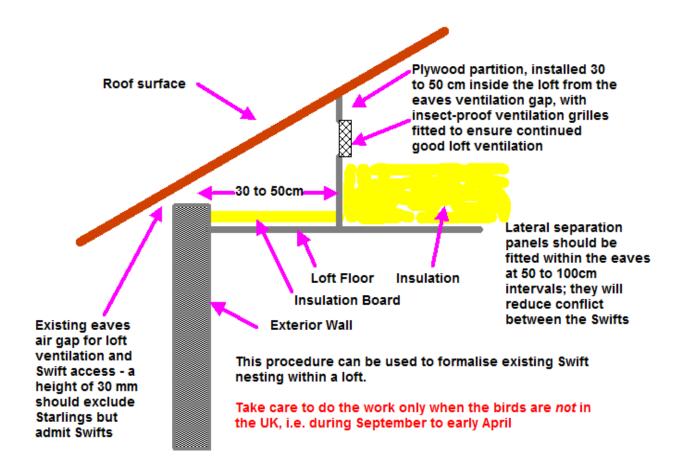
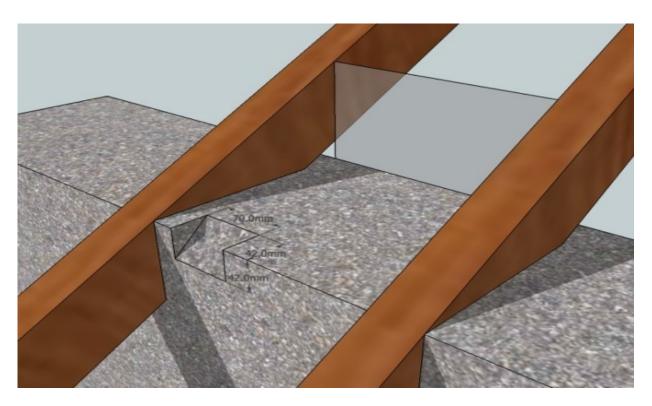
Above: examples of how to maintain Swift nest places in "open" eaves when these have to be rebuilt or re-roofed. For more advice and help on this and other ways of helping Swifts survive in the modern world please contact Swift Conservation
