Peatland Action Project: Tayside Experience and Cairngorms Demonstration

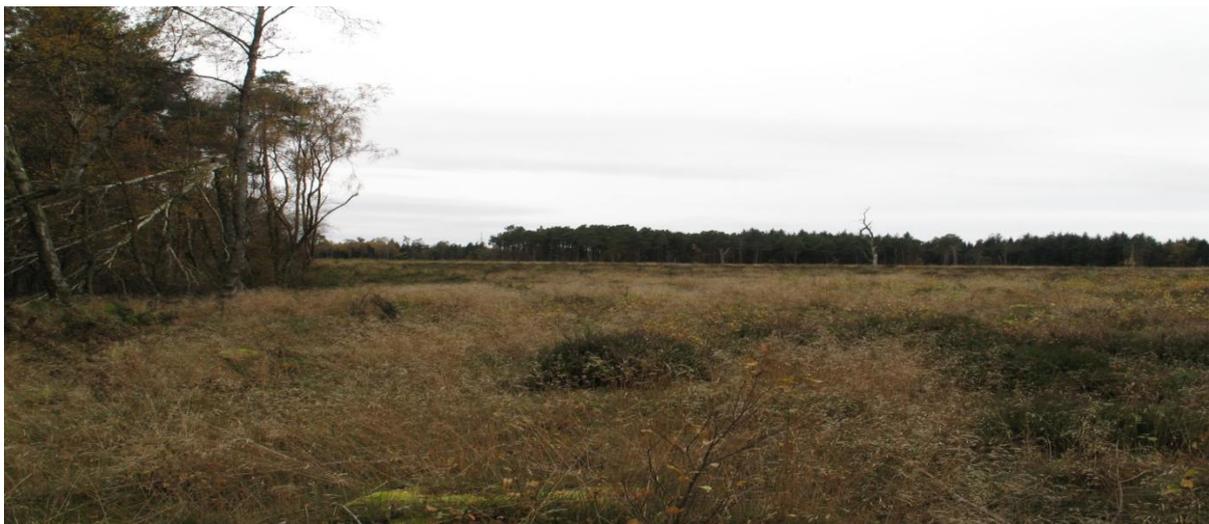
Portmoak Moss, 27th October, 2012

These two photographs are taken from opposite sides at the bog surface and compare the condition before and after restoration. Bog pools were formed in the process of recent work, sometimes using the previously dammed ditches, but removing their linear form which had stretched over much of the bog surface. Sphagnum species were present in 2012, but were confined to hollows. Wavy Hair-grass, *Deschampsia flexuosa*, was dominant to co-dominant over most of the surface, reflecting the drier areas as seen in the first photograph. Heather, *Calluna vulgaris*, was regenerating, but Cross-leaved Heath, *Erica tetralix*, was very occasional and Hare's-tail Cottongrass, *Eriophorum vaginatum*, was restricted; these two latter species are more typical of bog plant communities.

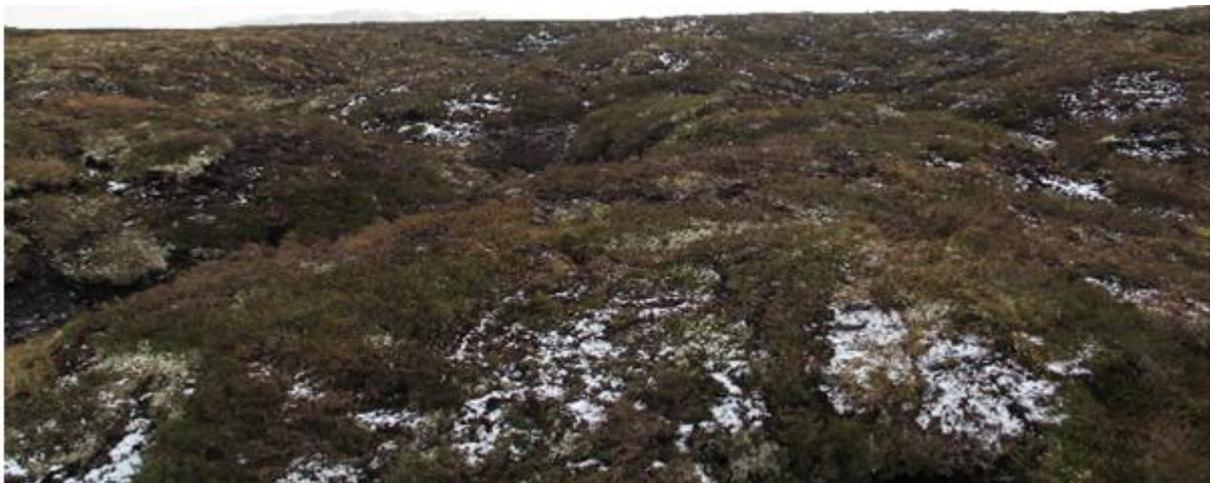
Camock Hill hag re-profiling

Our first view of recent work was re-profiling of hags to cover bare peat with adjacent vegetation. Had I not been told, I would have passed this by without paying further notice as there was very little evidence of disturbance. In an area of wetter peat, a peat dam had been formed to stem the loss of water and reduce erosion and the loss of peat.

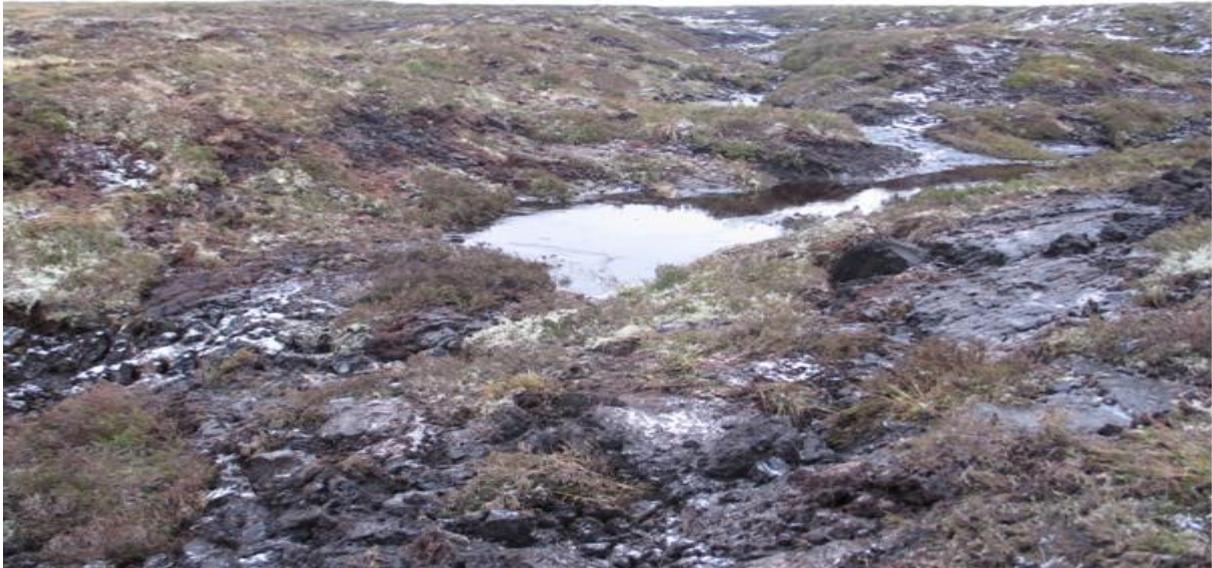
Camock Hill hag re-profiling and peat dam

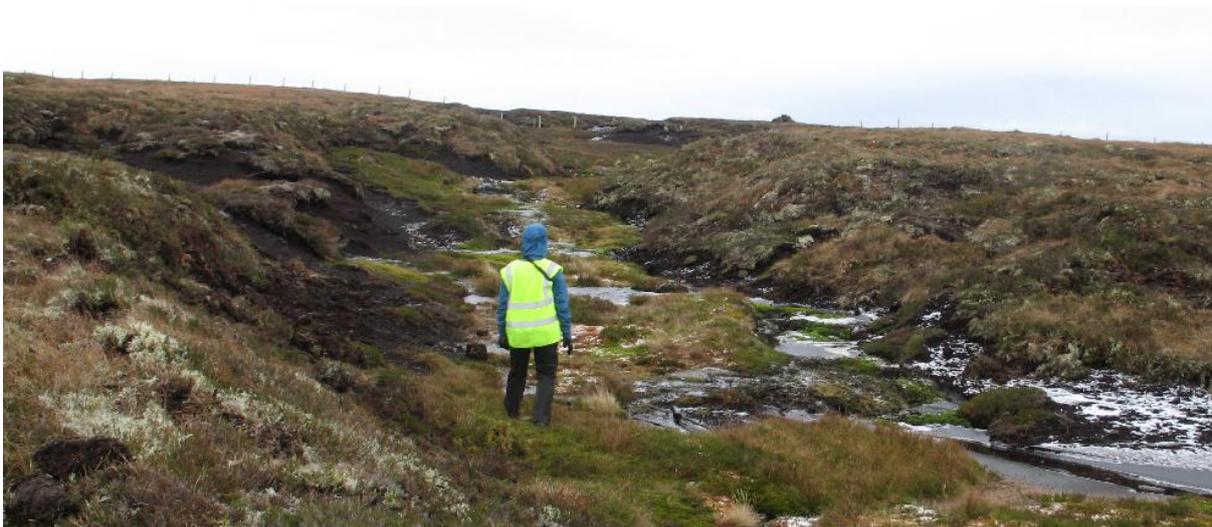
Top of erosion gully through blanket bog vegetation

The gully which had formed in the peat appeared to be entirely natural and a considerable collapse must have taken place. Vegetation had colonised some of the bare peat along the bottom of the gully, but elsewhere bare peat was present along the bottom and on the sides of the gully.

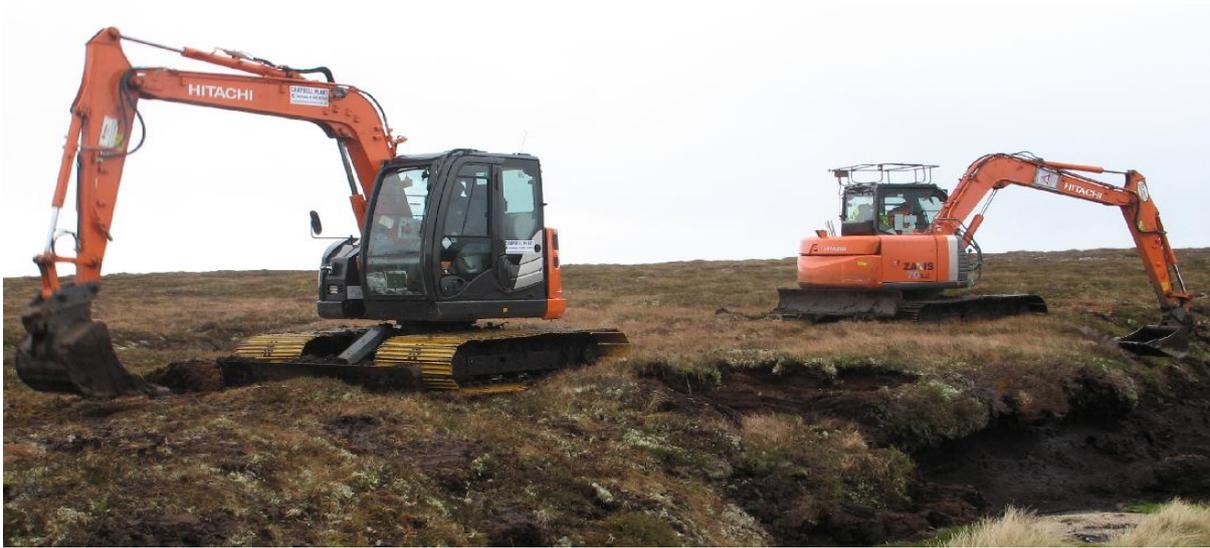
Twins!

The two excavators worked very well in tandem. The next photograph shows one of the excavators on the top of the bank which had been graded. Vegetation was being taken from the rear of the bank in large turves using the bucket of the excavator, which also tamped them down after laying them in place on the face of the bare peat. This action can be undertaken with one swing of the arm of the excavator, which can achieve 360° rotation.

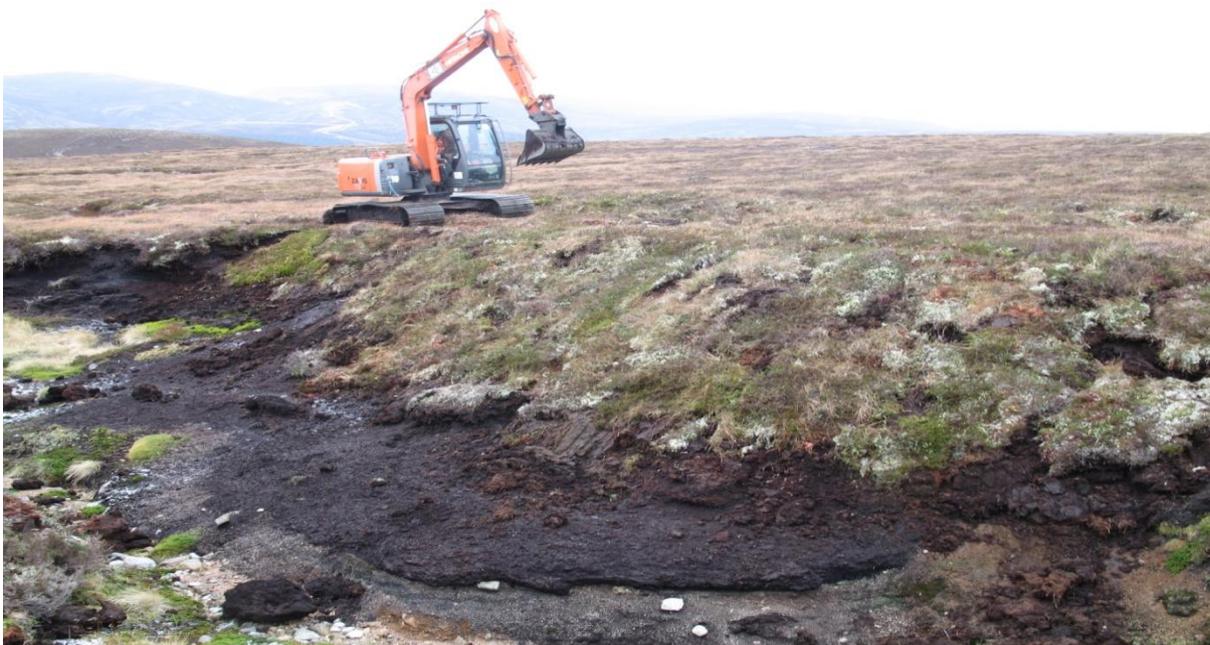
Top of re-profiled bank with translocated vegetation

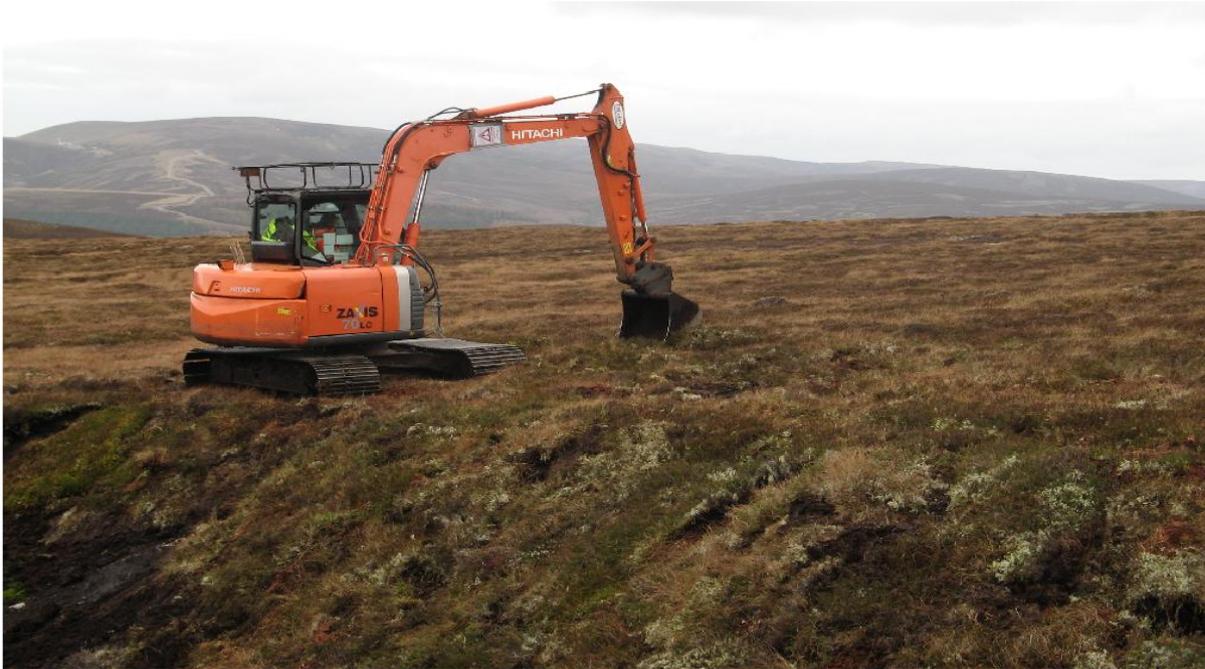
The large turves are taken from borrow pits at dispersed distances to avoid causing erosion. After the peat and its vegetation have been removed, the edges of the borrow-pit are raked in with the teeth of the bucket of the excavator to cover any bare peat. This can lead to the formation of shallow pools on the bog surface, which can be beneficial for invertebrates and attract high-level waders and other birds.

Removing turf

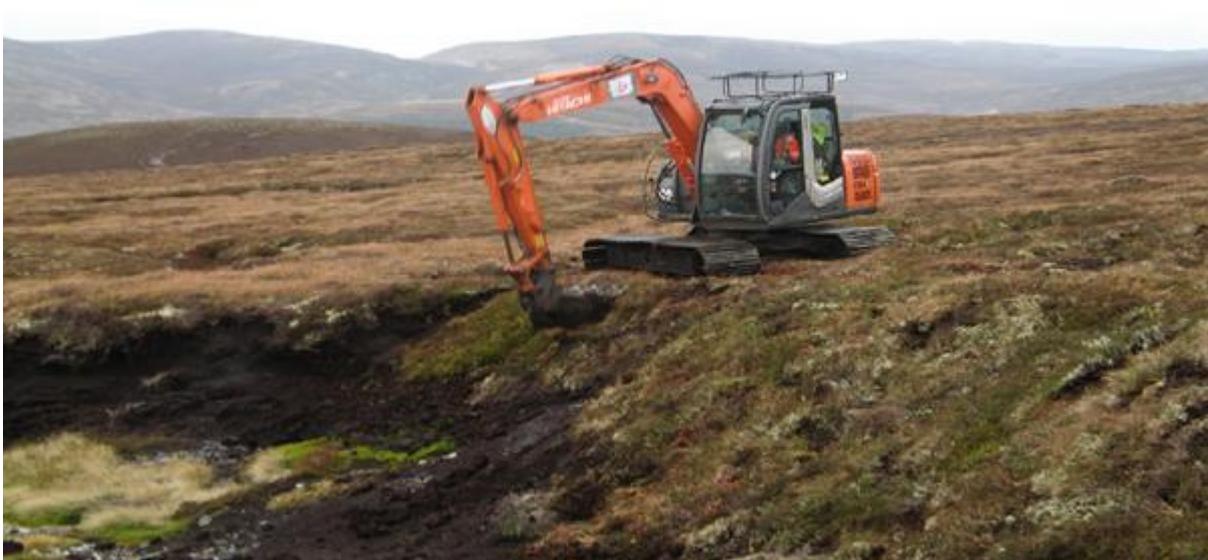
Tamping down turf which has been laid in place

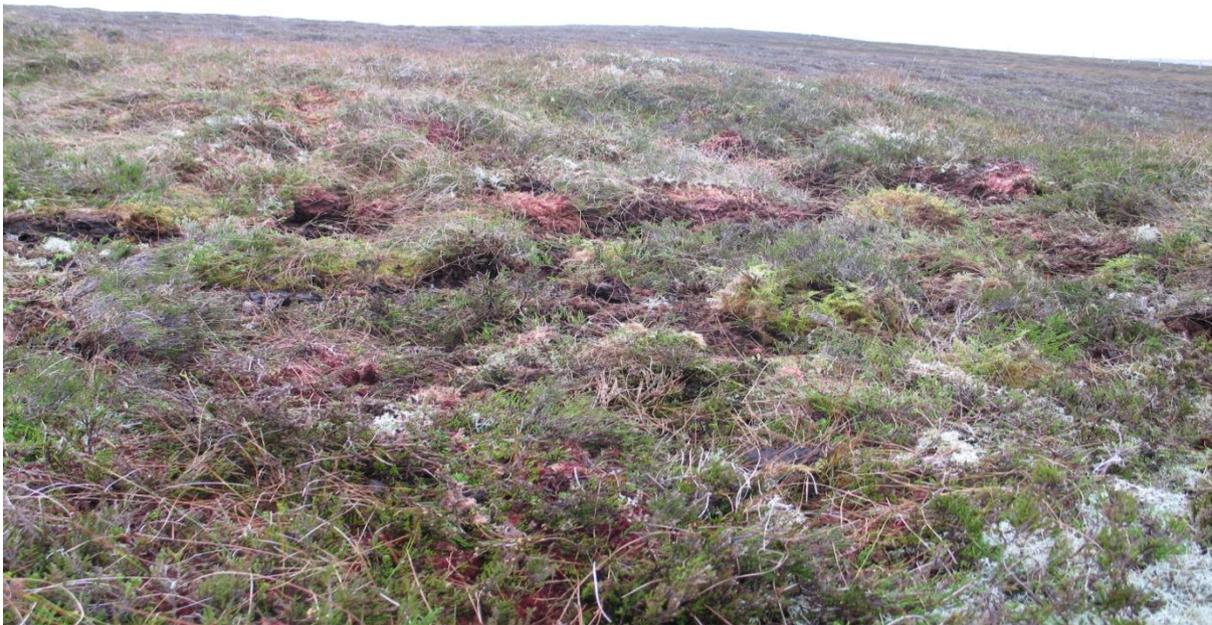
each day. The bank we watched from was where the excavators had been earlier that morning. The final photograph in this section was taken from this location and shows the results of a reinstated borrow pit.

Removal of vegetation must ensure only the minimal amount of peat is disturbed and any peat removed during re-profiling must be incorporated below translocated vegetation. Inevitably some bare peat remains on slopes which are too steep for re-profiling or on surfaces where vegetation has become exposed by erosion and replacement by immediately translocated vegetation is impractical.

Borrow-pit with reinstated vegetation

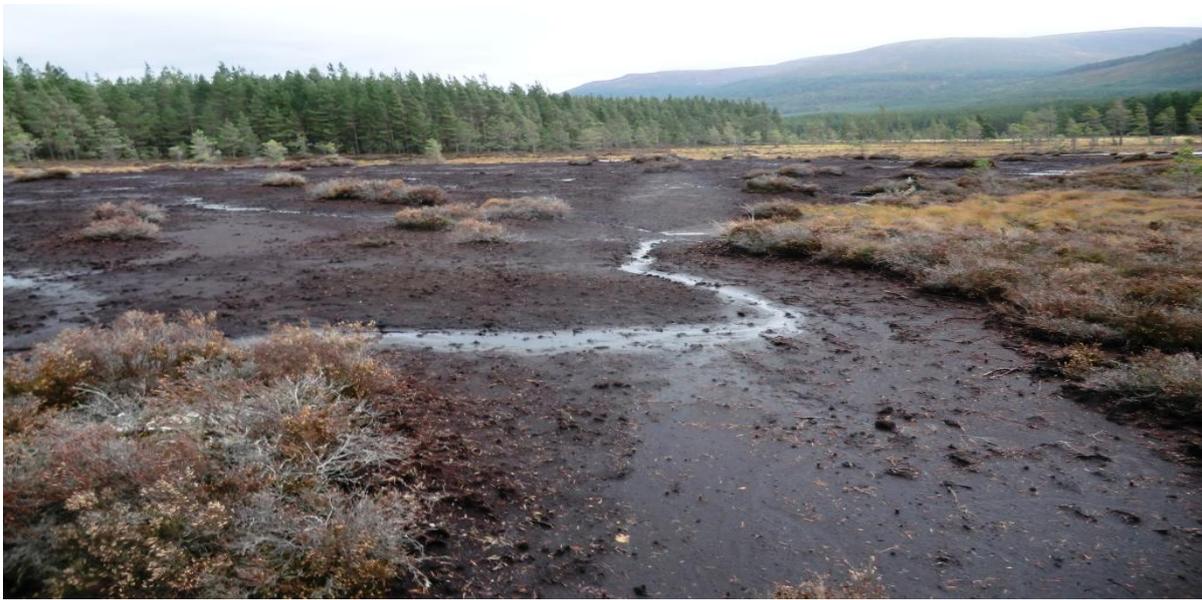
Inshriach Forest prior to September 2014

We were not able to see the restoration process described above, but Stephen kindly provided a number of photographs from another of his project sites to illustrate this. These were taken at Allt a'Mharcaidh, Inshriach Forest, Strathspey, where 4 hectares of bare peat had been spread with a sphagnum-rich mulch in December 2014. Results have been encouraging, with better results on the southern half of the site. New growth was achieved just 6 months after completion, as shown in the following photographs.

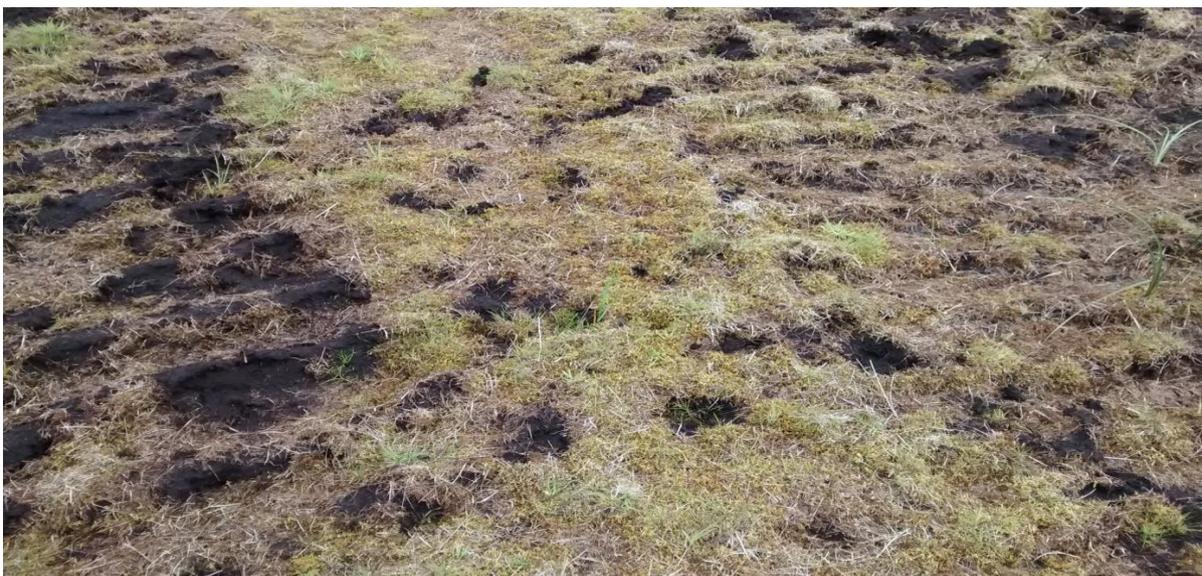
Establishment 6 months after treatment

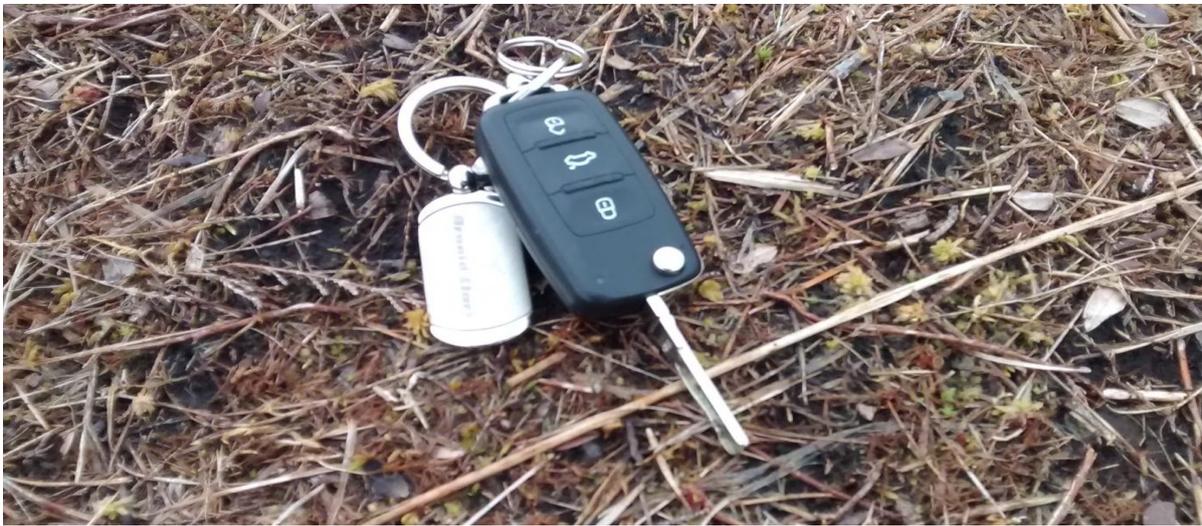
Detail of establishment showing capitular growth of sphagnum, particularly to the right
